WATER OPERATION AND MAINTENANCE

BULLETIN NO. 156

June 1991

Bureau of Reclamation

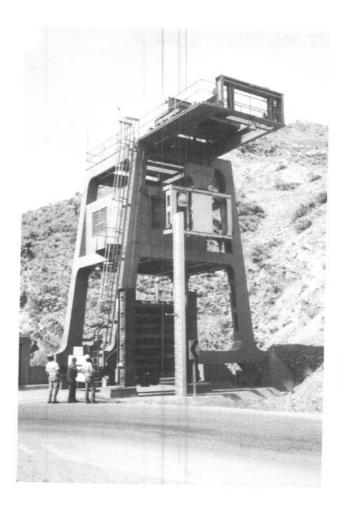
Bulkhead gate stored below gantry crane at Canyon Ferry.

A further measure to protect the seals is storing the bulkhead gates or stoplogs off the ground or operating deck on blocks to prevent compressing the seals during nonuse. Wooden planks, or other inexpensive material, are used to support the main sections of the bulkhead gate or stoplog and to provide the clearance for the seals.

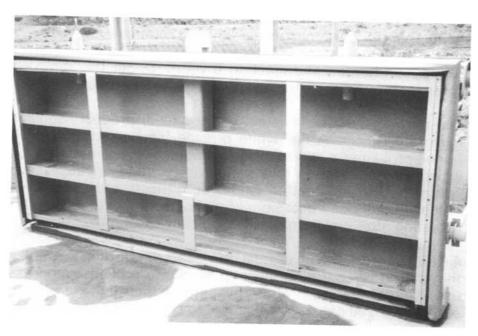
Duct tape over neoprene seals on large bulkhead gate at Stampede Powerplant.

The Lahontan Basin Project Office has a partial solution to the weathering problem. Project personnel have covered the neoprene seals of the larger bulkhead gate for their Stampede Dam Powerplant with duct tape. Duct tape has protected the seals, but the tape has deteriorated in the sunlight causing a separation between the adhesive and outer layers of the tape. Project personnel recommend that a more ultraviolet resistant material be used for seal protection.

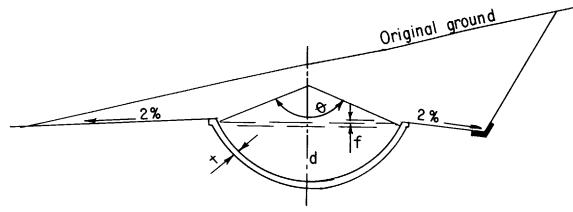
SEMI-CIRCULAR CANAL PRISM Figure 1

1.-Typical section in cut

Semicircular canals have some potential cost saving advantages, and they should be studied in more detail if the initial conditions seem favorable to this method of construction.

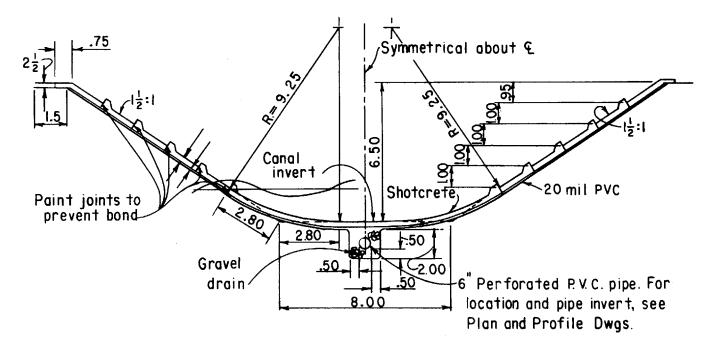
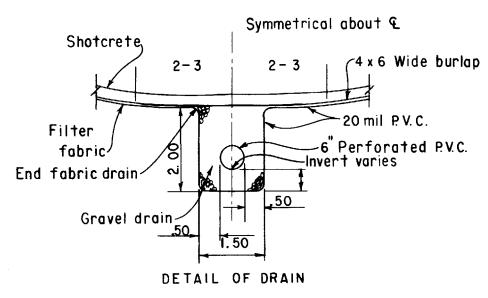
TOWAOC CANAL - SHOTCRETE CANAL SECTION Figure 2

DETAIL OF LINING (Dimensions in feet)

HYDRAULIC PROPERTIES

Q	Α	٧	r	n	S	þ	d	нв	HL
345	86.43	3.99	3.16	.017	.00045	8.00	5.44	8.20	6.50

The Bureau of Reclamation has designed lining for approximately 1 mile of canal with shotcrete over a geosynthetic on the Towoac Canal for the Dolores Project in Colorado. This method of construction was chosen for several reasons. First, 1 mile is too short a reach of canal to economically use a custom-built lining machine. Second, this project was a canal rehabilitation where the canal was only out of service for a short time during the year, and this method was chosen to complete this work in this short time. Finally, this area is on a steep hillside with silty material — it must be extremely watertight to prevent any failures. An underdrain was provided to collect any seepage before it entered the embankment.

Figure 2 shows details of this type of lining. Certain construction considerations are required for the PVC. After the canal subgrade is prepared by excavating, trimming, and dragging, 20-mil PVC is installed on the subgrade. A prefabricated drainage composite is installed directly on the PVC lining. The drainage composite is manufactured with the symmetrical nodal configurations on one side so that the flat backside can be installed directly on the PVC lining, and a nonwoven needle-punched geotextile is bonded to the nodal configuration. The shotcrete is then applied to the needle-punched geotextile. This is required so the shotcrete will not slump on the 1-1/2:1 surface. Several longitudinal open joints and transverse open joints every 30 feet are provided to allow drainage of water between the shotcrete and the PVC lining. The shotcrete is pneumatically applied concrete placed directly onto the needle-punched geotextile. It has a 3,000-lb/in² strength, and a wet-mix process was used to better control the composition of the mixture. Only the accelerator is allowed to be added to the mixture at the nozzle. The allowable slump for the shotcrete is 3 inches.

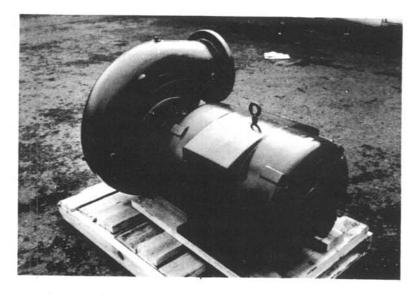
Inspecting pumps regularly is the first step in pump protection.

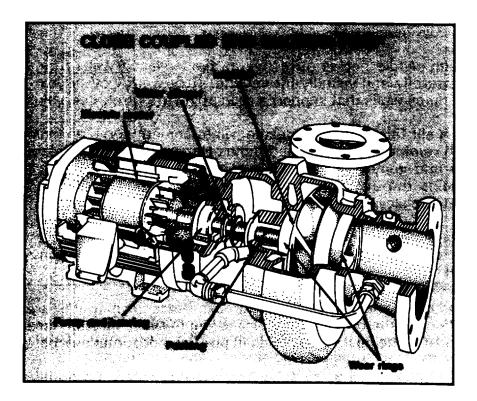
Feel the motors and pumps. Are there any strange noises or vibrations? Can you detect a bearing or motor that is unusually hot? Is there a new odor or electrical smell?

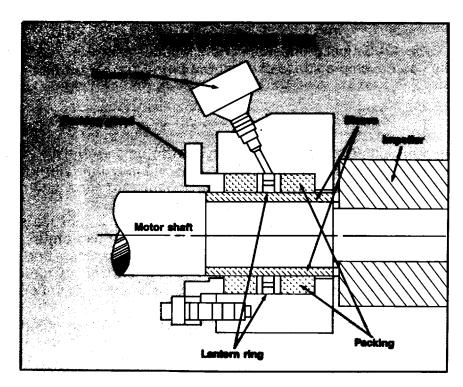
You can easily adjust the packing gland and grease cup to the manufacturer's instructions. Special lubrication for the grease cup and packing is available from local suppliers. The grease cup lubricates the packing and aids in priming horizontal pumps.

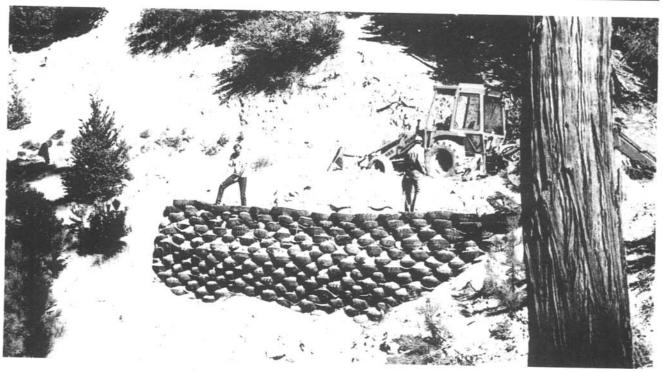
A tire-faced wall in a California forest.

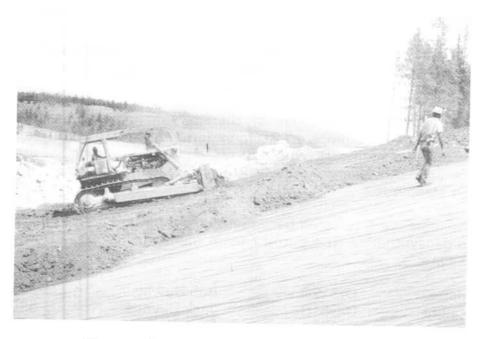
Geomembrane liner at Mt. Elbert Forebay.

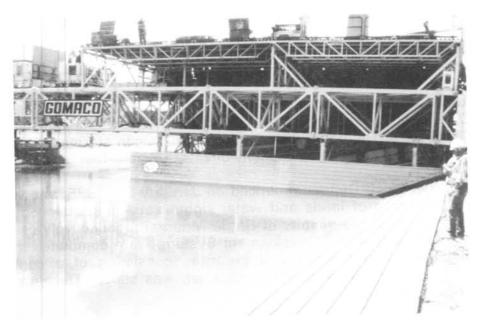
Underwater canal liner at Coachella Canal.

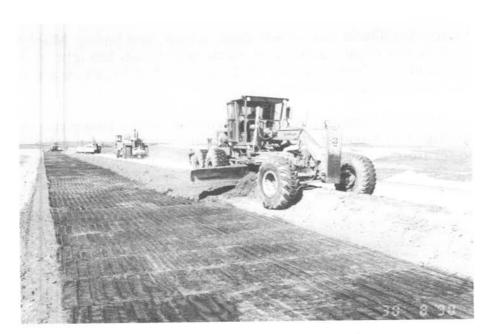
Geogrid placement at Davis Creek Dam.
